**We are often asked why the footings we offer are considerably more expensive than those of other silo suppliers. Typically, the comparison is between an engineered footing constructed with deep excavated beams against a slab poured on top of the ground. So why the difference?**

### **The Depth of the Excavation for the Footing**

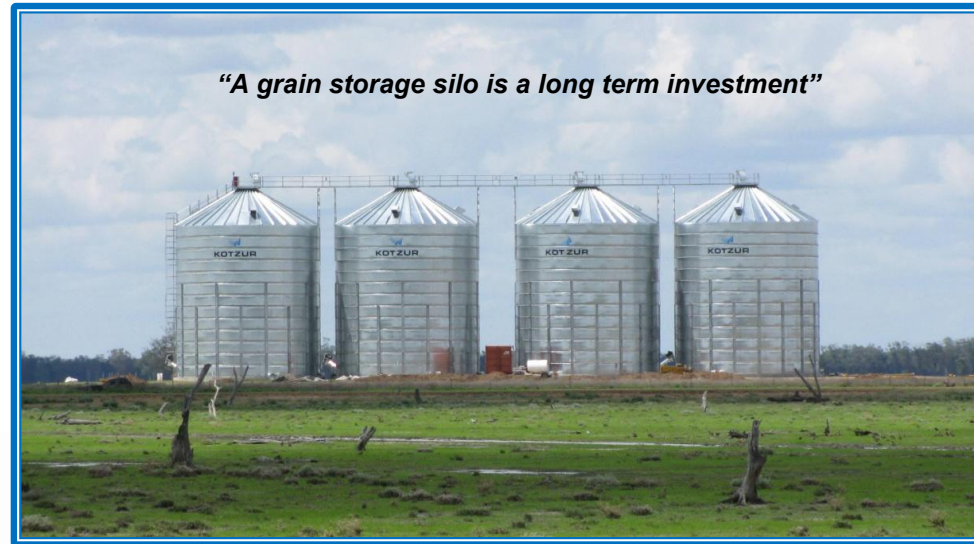
To be strong, it needs to maintain the thickness for the entire perimeter. Therefore if there are step downs (e.g. for aeration), then there is often a corresponding increase in the depth of the beam. Kotzur engineered footings usually have at least 750mm thick edge beams (both below and above ground) and are often excavated to a depth in excess of 450mm.

The key design criteria being to ensure the slab is strong enough to withstand any local soil movement without cracking and compromising the gas seal of the silo.

The Kotzur engineered footing is designed to have the perimeter of the footing (where the majority of the load is) sitting on stable, high load bearing soil well below natural ground level. Often it is necessary to have a soil test undertaken to determine the desired depth and the strength of the soil. Both of these factors influence the final footing design. The advantages of this footing design are:
